EXPERT 1K-fa, repair after Field day Contest 2017

The Clubstation OZ6FRS is owner of an EXPERT 1K-fa since 2010, and was in use in the past Fieldday Contest September 2017, working on the 20 meter band, SSB and CW. Operating for approximately 20 hours and operating temperature was never higher than 65C.

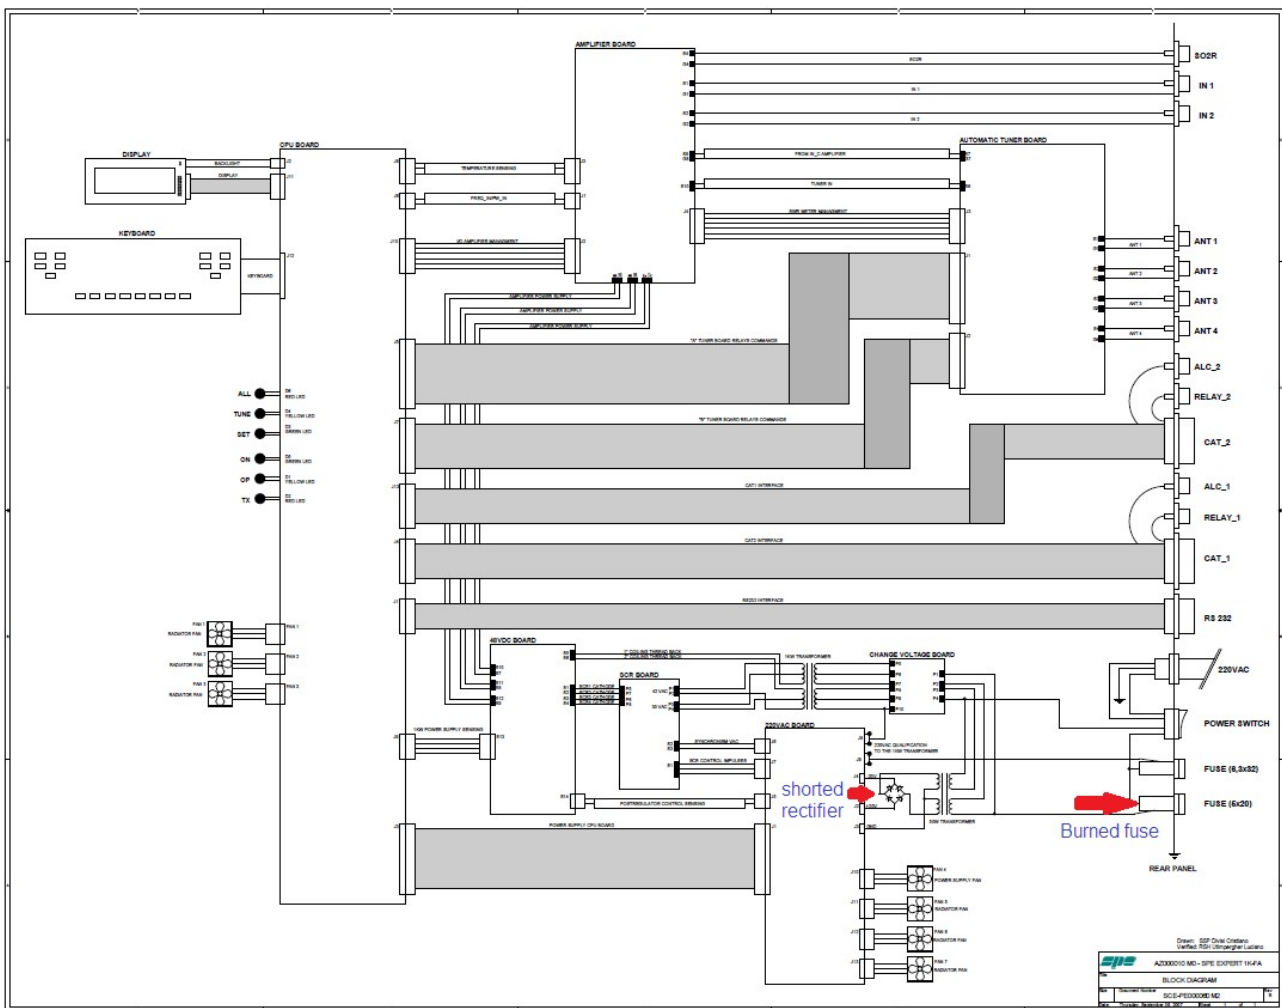
The cause of the failure was traced to rectifier bridge KBPC808, where the negative side of diode bridge had short-circuited to ground

The symbol for the rectifier is turned wrong in this picture.

We had to shorten the 3mm bolt by 2-3 mm (remember to keep the nut in place, and then cut as close as possible on top of the nut). Thereafter it was barely possible to remove the rectifier. We found a substitute PBU807 with minor better data, but a lot easier to remount.

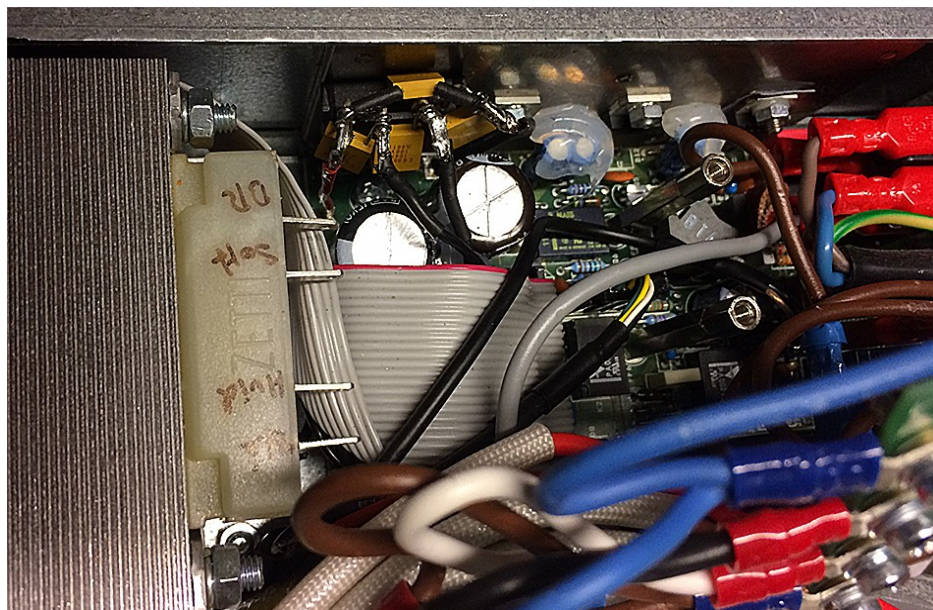
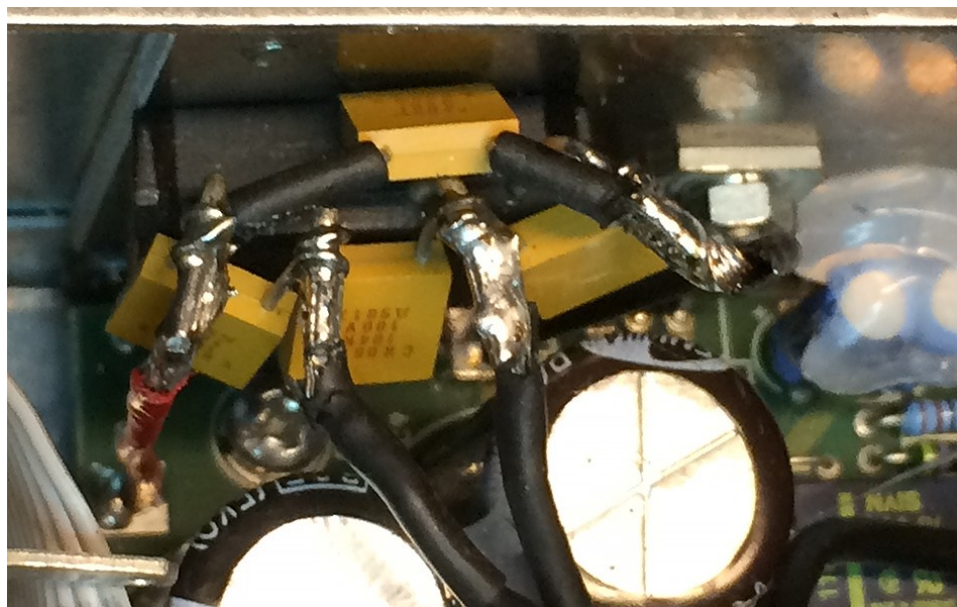
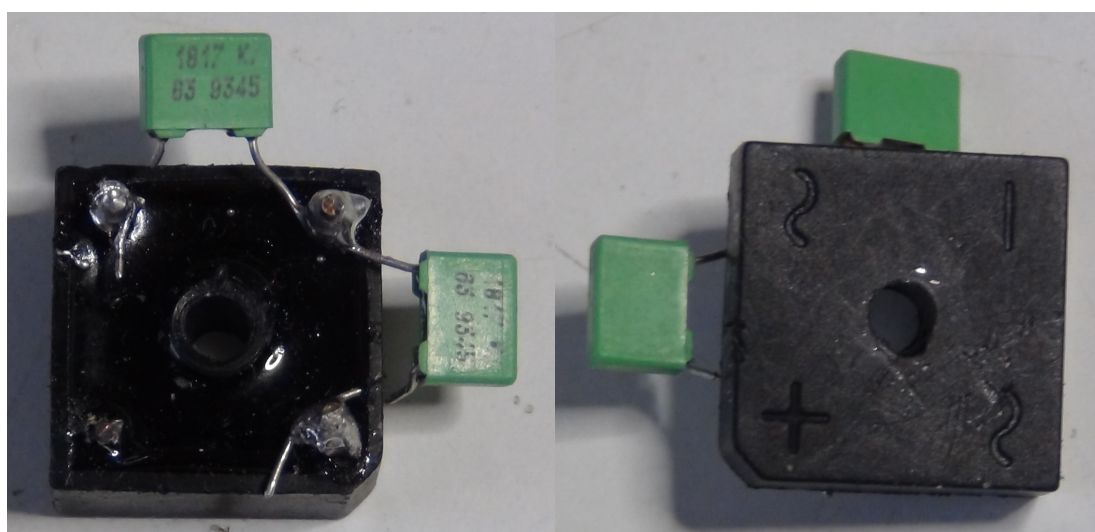
BUT, the big problem was to remove the rectifier bridge from its position, in order to avoid un-mount the complete 220VAC board.
